**Flood Control Project Maintenance
Levee Inspections**

Spring 2012 Levee Inspection Results

Reclamation District No. 0010 Honcut

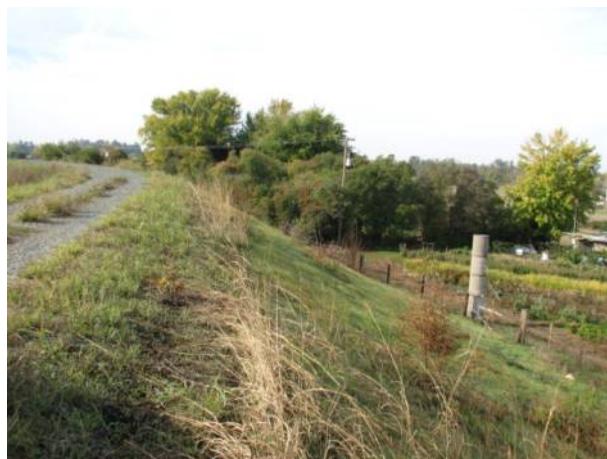
Levee Mile Report Line	4
Start Levee Mile	0.01
End Levee Mile	0.57
Location	Land Side
Category	Earthen Levee
Item	Vegetation

This photo shows the landside vegetation at levee mile 1.35.

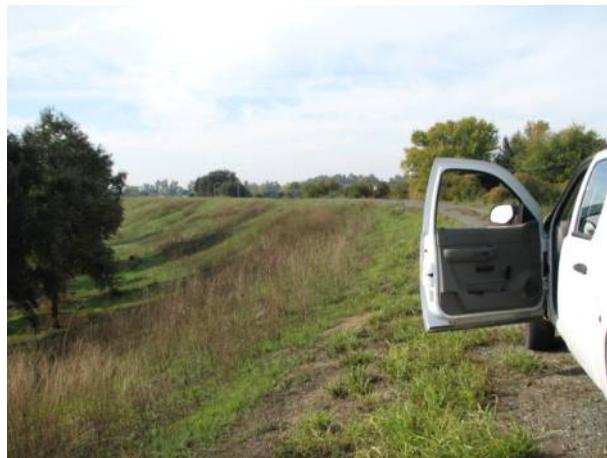
Levee Mile Report Line	5
Start Levee Mile	0.01
End Levee Mile	0.57
Location	Water Side
Category	Earthen Levee
Item	Vegetation

This photo shows the waterside vegetation at levee mile 1.35.

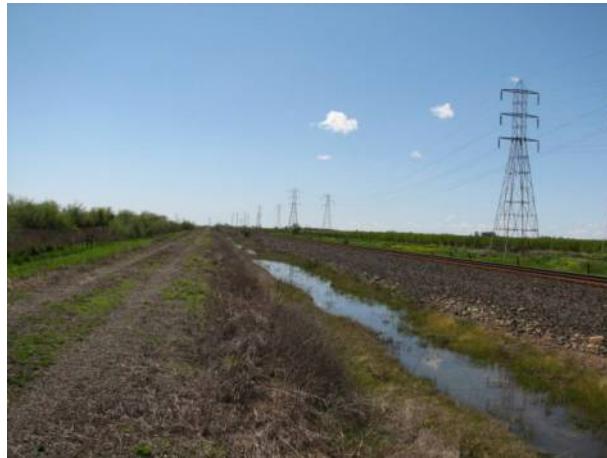
Levee Mile Report Line	6
Start Levee Mile	0.05
End Levee Mile	7.67
Location	Land Side
Category	Earthen Levee
Item	Vegetation

View of the landward slope looking downstream.

DWR ID: DWR_RD0010_01_s_2012_8			
6	0.05 7.67	Earthen Levee	Vegetation	LS A Ma	V1 : Control annual grass and weeds on the levee slopes and easements.			39.163687 ° 39.256085 ° 3 -121.608957 ° -121.574914 ° Y			
								DWR ID: DWR_RD0010_01_s_2012_3			
7	0.05 7.67	Earthen Levee	Vegetation	WS A Ma	V1 : Control annual grass and weeds on the levee slopes and easements.			39.163687 ° 39.256085 ° 4 -121.608956 ° -121.574914 ° Y			
								DWR ID: DWR_RD0010_01_s_2012_4			
8	0.70 0.70	Earthen Levee	Trim / Thin Trees	LS A/W Ma	T2 : Thin trees to allow visibility of the ground and room to flood fight. Inspector Comments: saplings			39.161297 ° 39.161297 ° 6 -121.597434 ° -121.597434 °			
								DWR ID: DWR_RD0010_01_s_2012_6			
9	1.28 1.35	Earthen Levee	Encroachments	LS M En	FE : Fences			39.167977 ° 39.168704 ° 2 -121.591637 ° -121.590598 °			
								DWR ID: DWR_RD0010_01_s_2012_2			
10	1.35 1.35	Earthen Levee	Trim / Thin Trees	LS C Ma	T2 : Thin trees to allow visibility of the ground and room to flood fight.			39.168704 ° 39.168704 ° 5 -121.590601 ° -121.590601 °

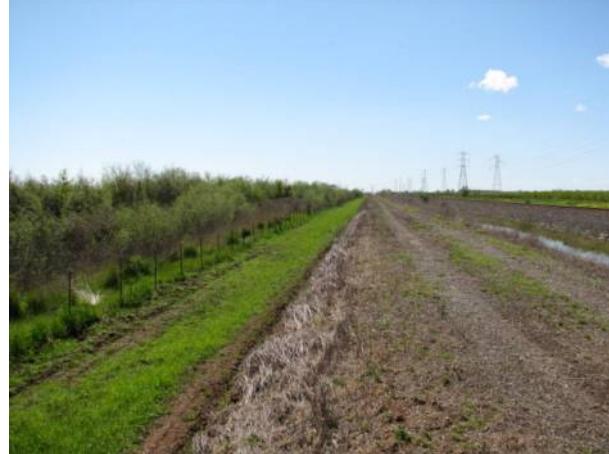
Levee Mile Report Line	7
Start Levee Mile	0.05
End Levee Mile	7.67
Location	Water Side
Category	Earthen Levee
Item	Vegetation

View of the waterward slope looking downstream.

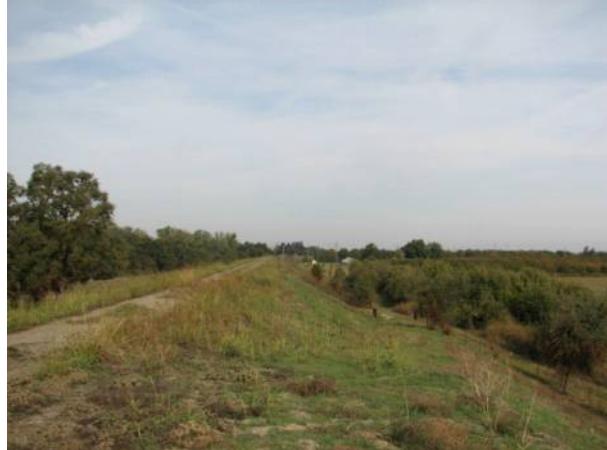
Levee Mile Report Line	1
Start Levee Mile	0.03
End Levee Mile	6.70
Location	Land Side
Category	Earthen Levee
Item	Vegetation

This photo shows the landside vegetation at levee mile 0.03.

1	0.03	6.70	Earthen Levee	Vegetation	LS	M	V2 : Remove the wild growth other than native grasses from the levee slopes.		39.164076 ° 39.257362 ° 1 -121.610073 ° -121.618135 ° Y DWR ID: DWR_RD0010_02_s_2012_1	
2	0.03	0.03	Earthen Levee	Animal Control	LS	C	A1 : Exterminate rodents and backfill and compact or grout burrows.		39.164076 ° 39.164076 ° 5 -121.610074 ° -121.610074 ° DWR ID: DWR_RD0010_02_s_2012_5	
3	0.03	6.70	Earthen Levee	Vegetation	WS	M	V2 : Remove the wild growth other than native grasses from the levee slopes.		39.164076 ° 39.257362 ° 2 -121.610074 ° -121.618135 ° Y DWR ID: DWR_RD0010_02_s_2012_2	
4	0.32	0.32	Earthen Levee	Animal Control	LS	C	A2 : Repair the levee slope damaged by livestock and prevent large animal access.		39.168247 ° 39.168247 ° 6 -121.610611 ° -121.610611 ° DWR ID: DWR_RD0010_02_s_2012_6	
5	0.66	0.66	Earthen Levee	Encroachments	LS	C	DE : Debris		39.173110 ° 39.173110 ° 8 -121.609946 ° -121.609946 ° DWR ID: DWR_RD0010_02_s_2012_8

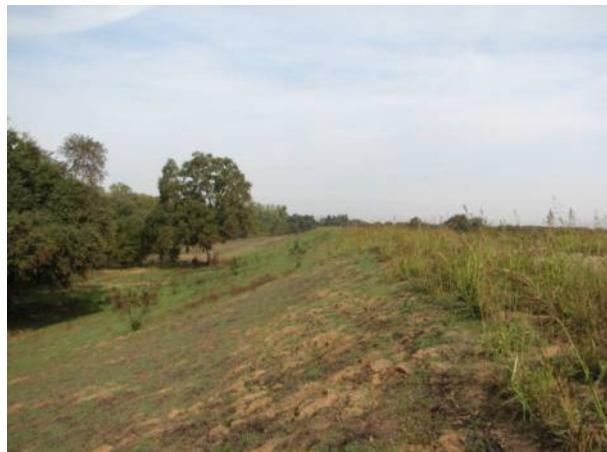
Levee Mile Report Line	3
Start Levee Mile	0.03
End Levee Mile	6.70
Location	Water Side
Category	Earthen Levee
Item	Vegetation

This photo shows the waterside vegetation at levee mile 0.03.

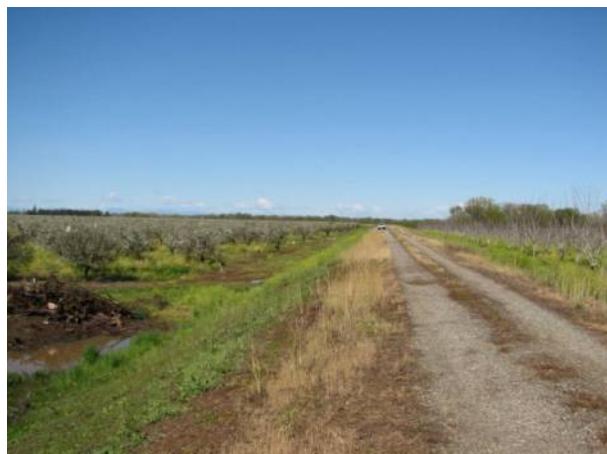
Levee Mile Report Line	13
Start Levee Mile	6.70
End Levee Mile	11.23
Location	Water Side
Category	Earthen Levee
Item	Vegetation

View of the vegetation on the slope.

12	6.61	6.61	Earthen Levee	Animal Control	LS	C	A1 : Exterminate rodents and backfill and compact or grout burrows.		39.256365 ° 39.256365 ° 16 -121.619088 ° -121.619088 ° DWR ID: DWR_RD0010_02_s_2012_16	
13	6.70	11.23	Earthen Levee	Vegetation	WS	M	V1 : Control annual grass and weeds on the levee slopes and easements.		39.257430 ° 39.307664 ° 28 -121.618062 ° -121.617110 ° Y DWR ID: DWR_RD0010_02_s_2012_28	
14	6.70	11.23	Earthen Levee	Vegetation	LS	M	V1 : Control annual grass and weeds on the levee slopes and easements.		39.257430 ° 39.307664 ° 27 -121.618062 ° -121.617105 ° Y DWR ID: DWR_RD0010_02_s_2012_27	
15	7.78	7.78	Earthen Levee	Encroachments	LS	C	DE : Debris		39.271606 ° 39.271606 ° 17 -121.611506 ° -121.611506 ° DWR ID: DWR_RD0010_02_s_2012_17

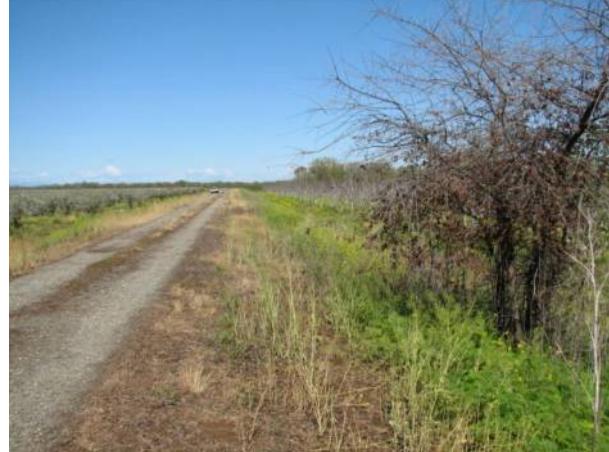
Levee Mile Report Line	14
Start Levee Mile	6.70
End Levee Mile	11.23
Location	Land Side
Category	Earthen Levee
Item	Vegetation
View of the vegetation on the slope.	
dpesaven_s_20120504_055.JPG

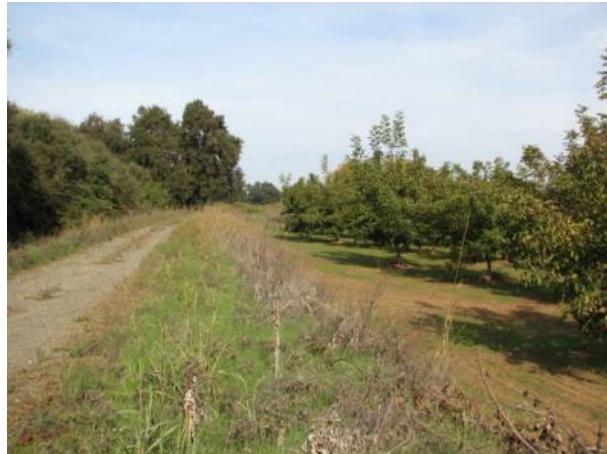
Levee Mile Report Line	1
Start Levee Mile	0.02
End Levee Mile	2.90
Location	Land Side
Category	Earthen Levee
Item	Vegetation

This photo shows the landside vegetation at levee mile 0.02.

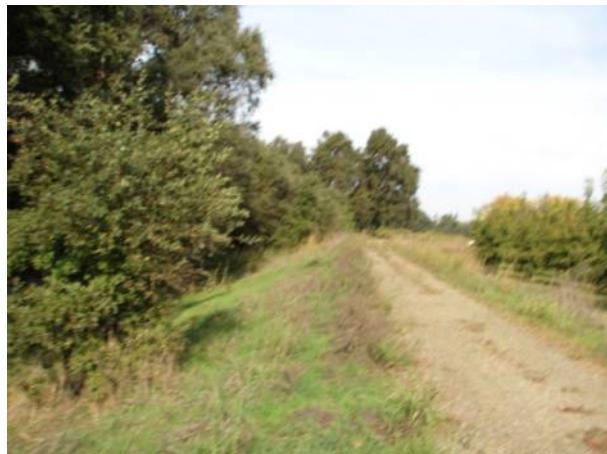
Levee Mile Report Line	2
Start Levee Mile	0.02
End Levee Mile	2.90
Location	Water Side
Category	Earthen Levee
Item	Vegetation

This photo shows the waterside vegetation at levee mile 0.02.
